CITY OF PALOS VERDES ESTATES, CALIFORNIA

GENERAL PLAN SEISMIC SAFETY ELEMENT

CITY OF PALOS VERDES ESTATES

SEISMIC SAFETY ELEMENT

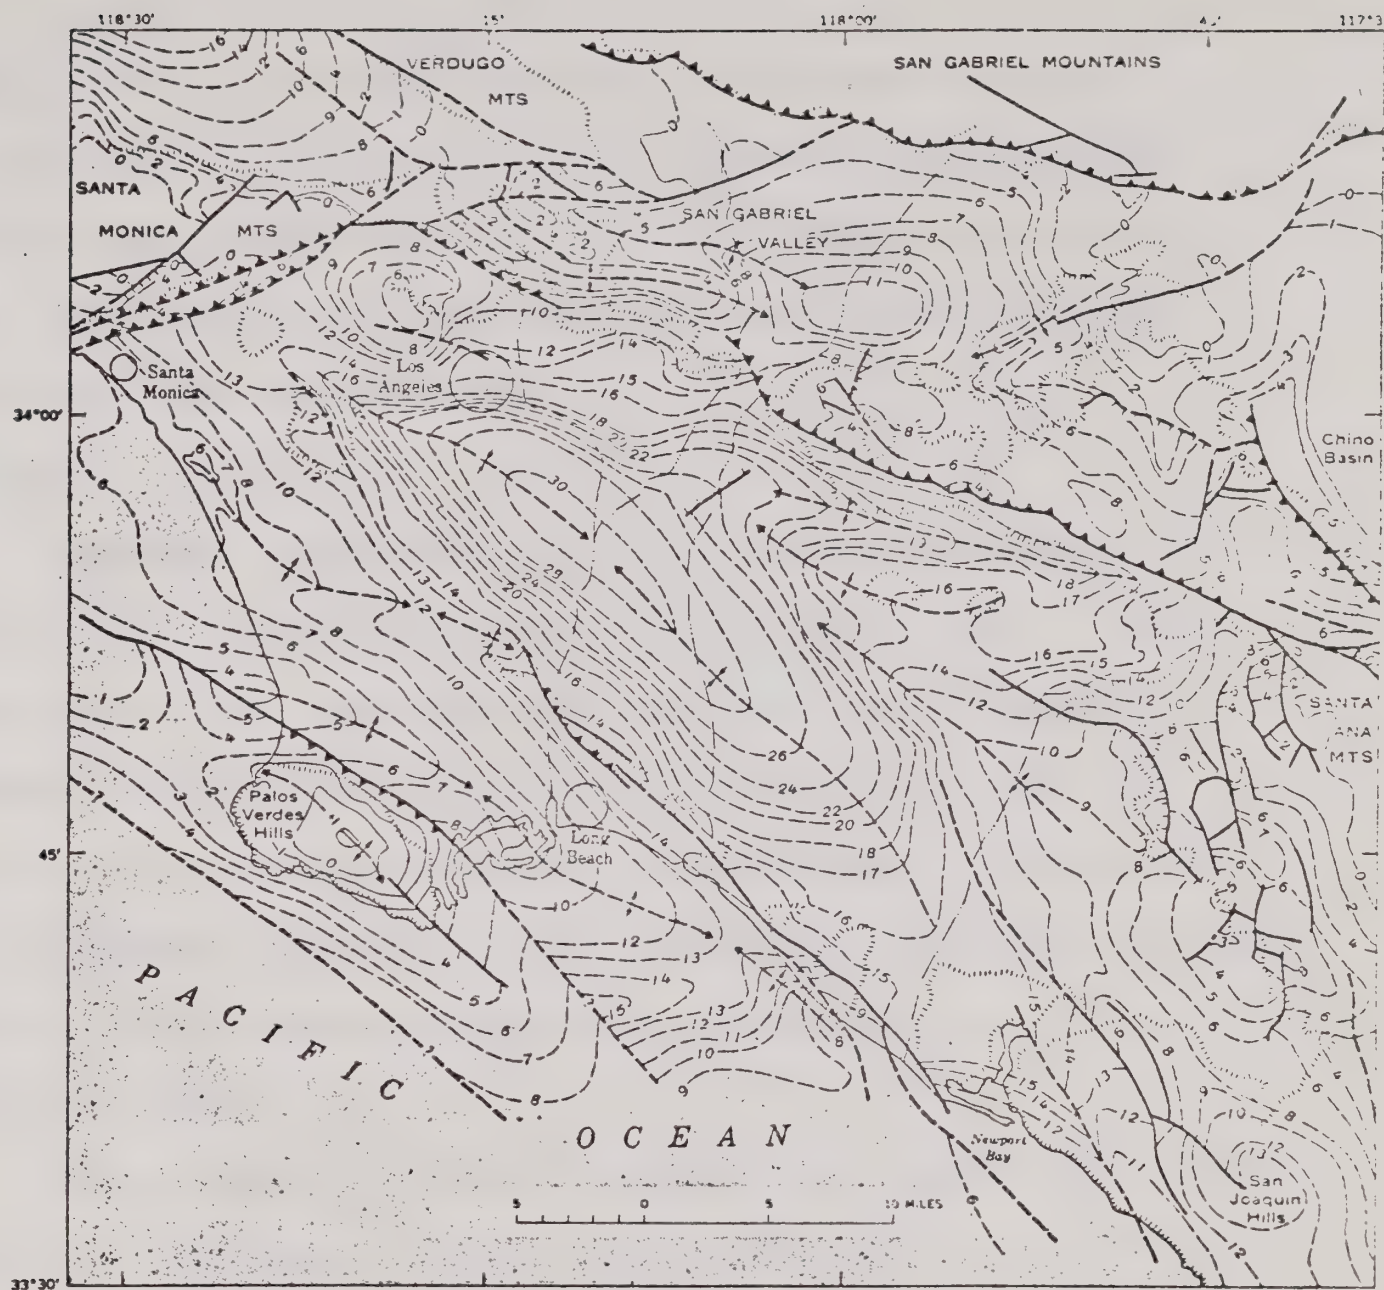
Figure 2. Major faults, structural features, and contours on basement rock, L.A. Basin (after Yerkes and others, 1965)

Ground rupture. The Palos Verdes fault trends in a northwesterly direction and lies several hundred yards northeast of Palos Verdes Estates (Fig. 2). The fault does not displace surface rocks, rather, it is manifest by a sharp downbending of Pleistocene deposits along the northeast edge of the hills. Subsurface data from deep wells and gravity profiles indicate the fault lies outside the study area and displaces older base --
